Scour and Scour Protection for Windturbine Foundations

for the London Array

Hydraulics and Coastal Engineering No. 17

May 2005

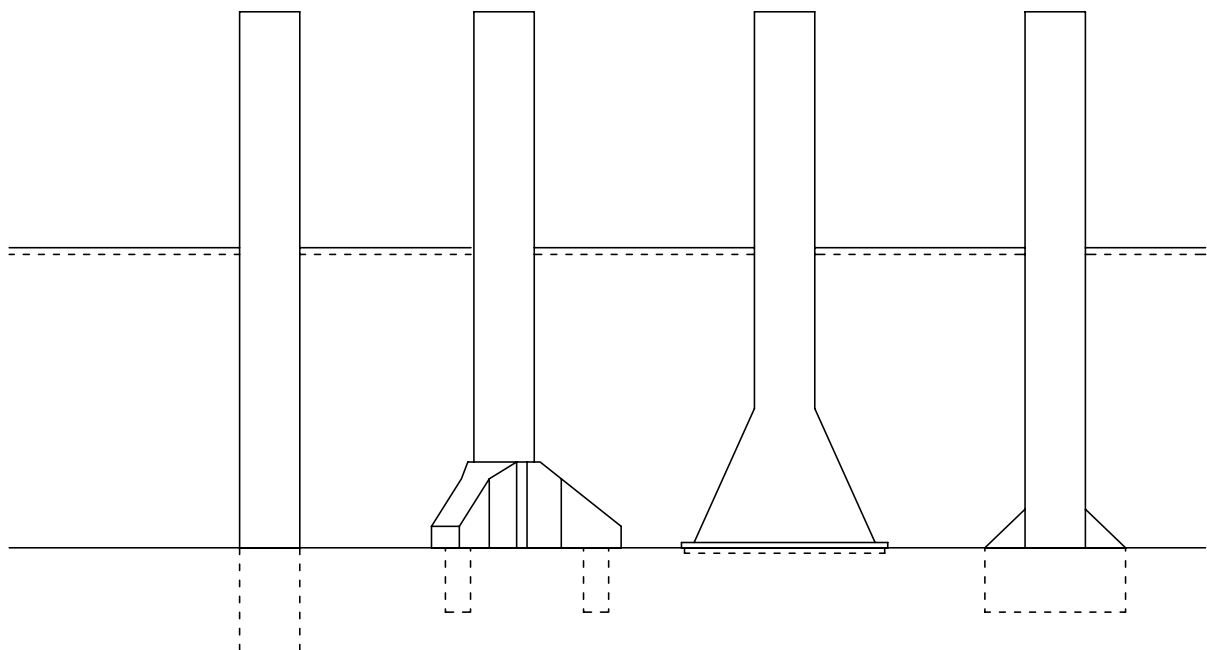
The four types of foundation that are being tested are shown underneath in figure 1. In appendix 2 the models are shown in detail.

Figure 1. Monopile Concrete tripod Concrete cone Suction bucket

The models are made of various types of plastic. The suction bucket has been added on initiative by Aalborg University in agreement with the client.

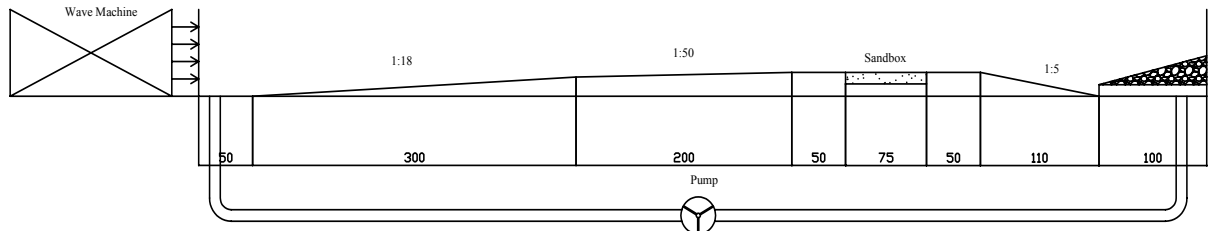
The tests are conducted in a wave flume that is 945 meters long and 75 meters wide, see figure 2.

Figure 2. The wave flume. All measures in meters.

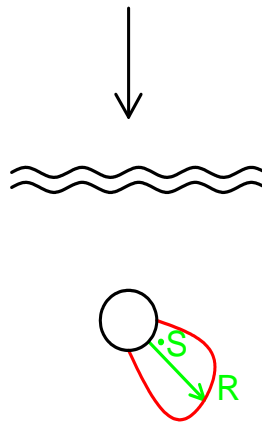
Figure 3. Definitions of S and R.

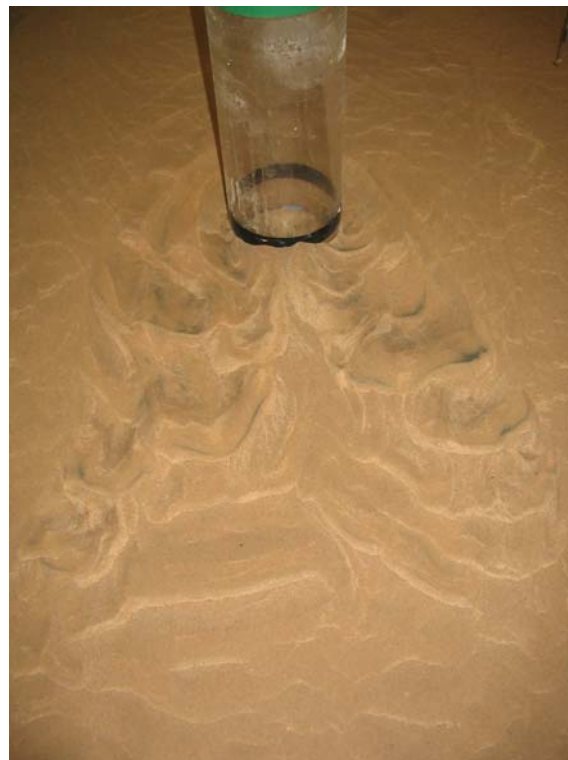
Figure 1.1. Scour hole at the end of 1.1.

Minutes	S [m]	R [m]
106	0.5	15
212	1.0	17.5
424	1.0	17.5

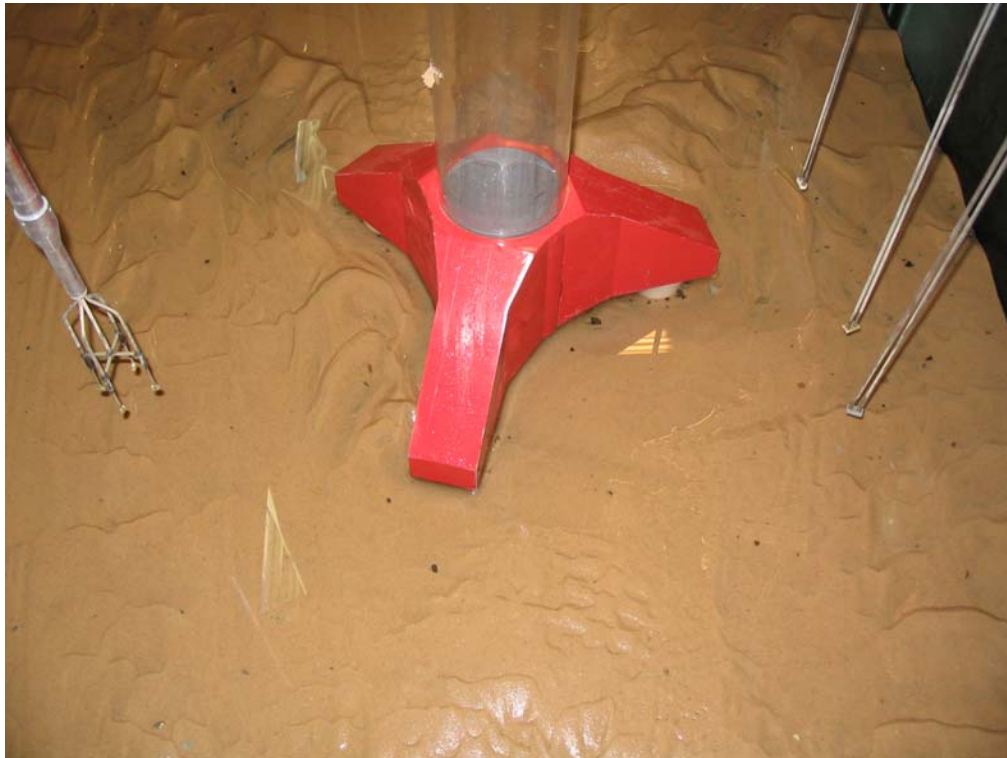
Figure 1.2. Scour hole at the end of 1.2.
The scour is occurring underneath the structure.

Minutes	S [m]	R [m]
106	1.5	2.5
212	2.0	3.5
424	2.5	5.0

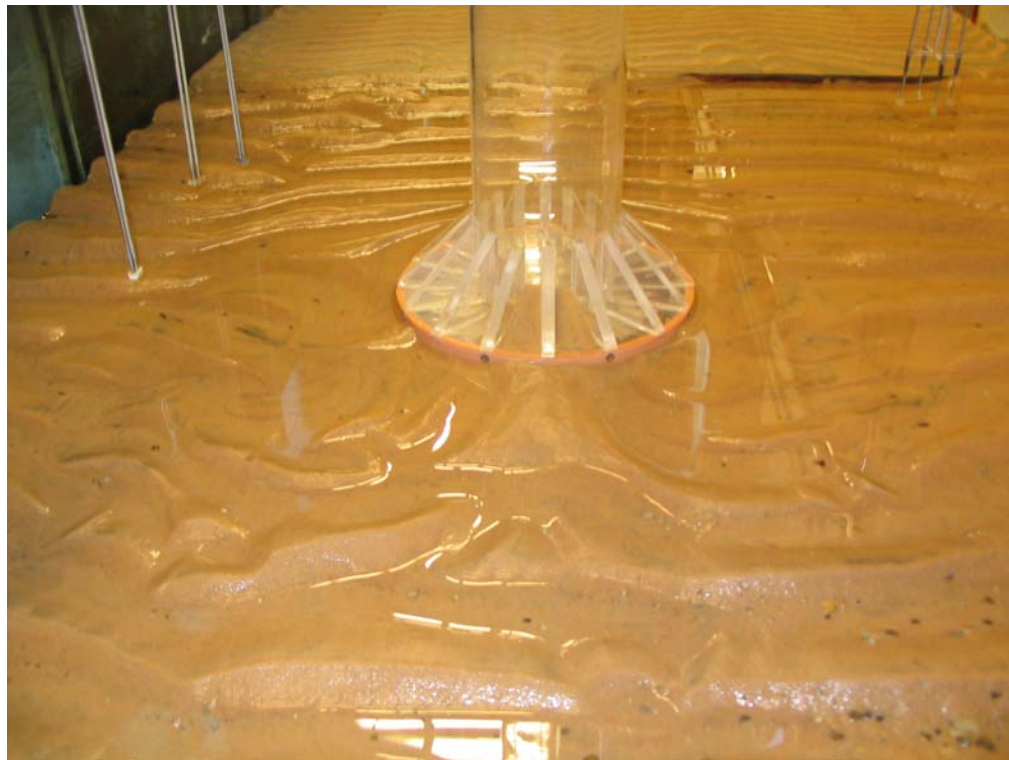
Figure 1.8. Scour hole at the end of 1.8.

Minutes	S [m]	R [m]
106	1.0	10.0
212	1.5	10.0

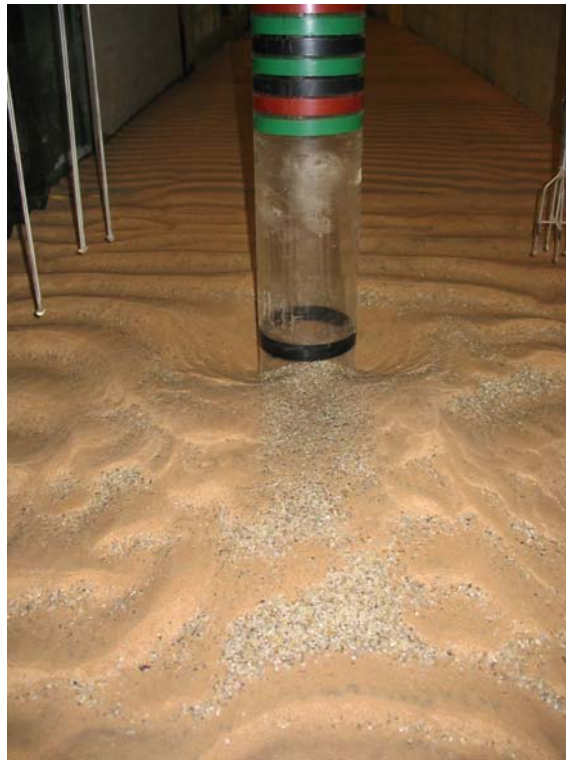
In this test protection type number one was used. It has a D_{50} of 93 mm.

Figure 1.11. Shape of scour protection at the end of 2.2. Complete damage. 2.5 m scour depth.

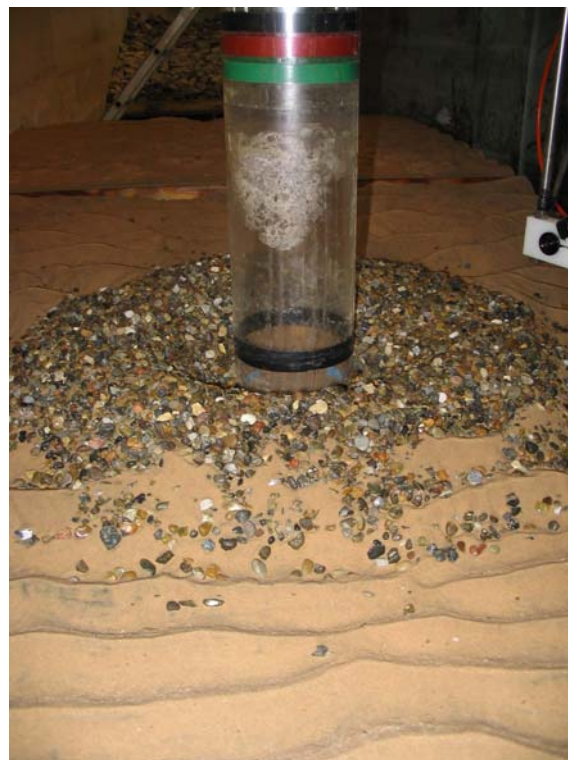
In this test protection type number two was used. It has a D_{50} of 258 mm.

Figure 1.13. Shape of scour protection at the end of 2.3.
Severe damage. 1.5 m scour depth.

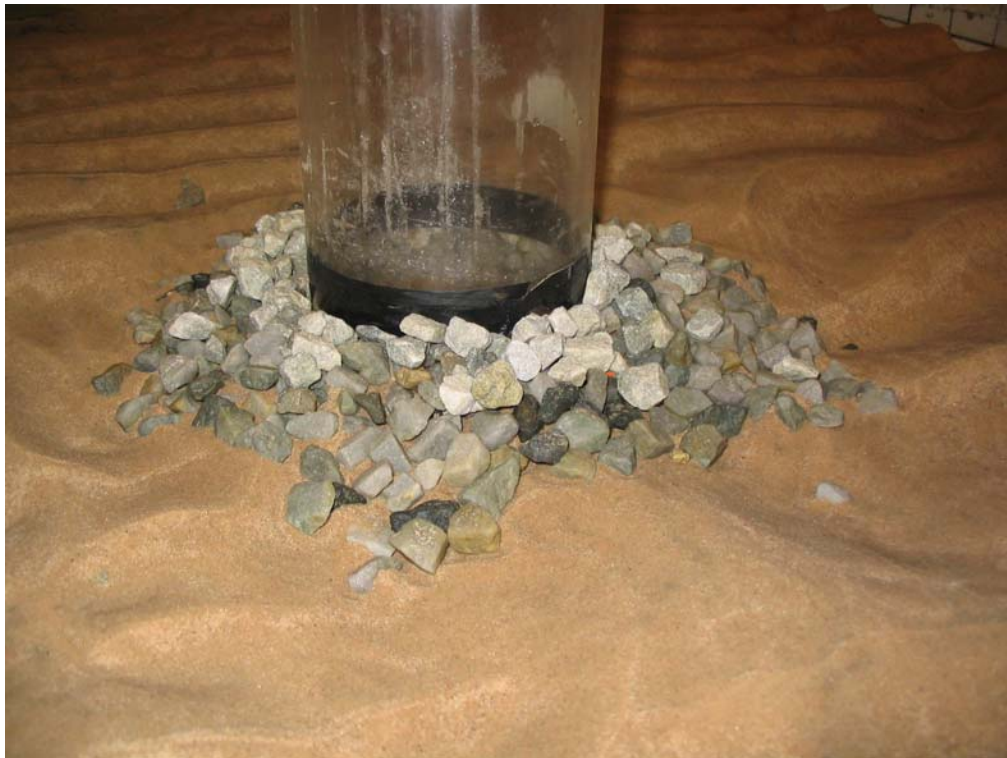
In this test protection type number three was used. It has a D_{50} of 585 mm.

Figure 1.19. Shape of scour protection at the end of 2.6.
No damage occurred.

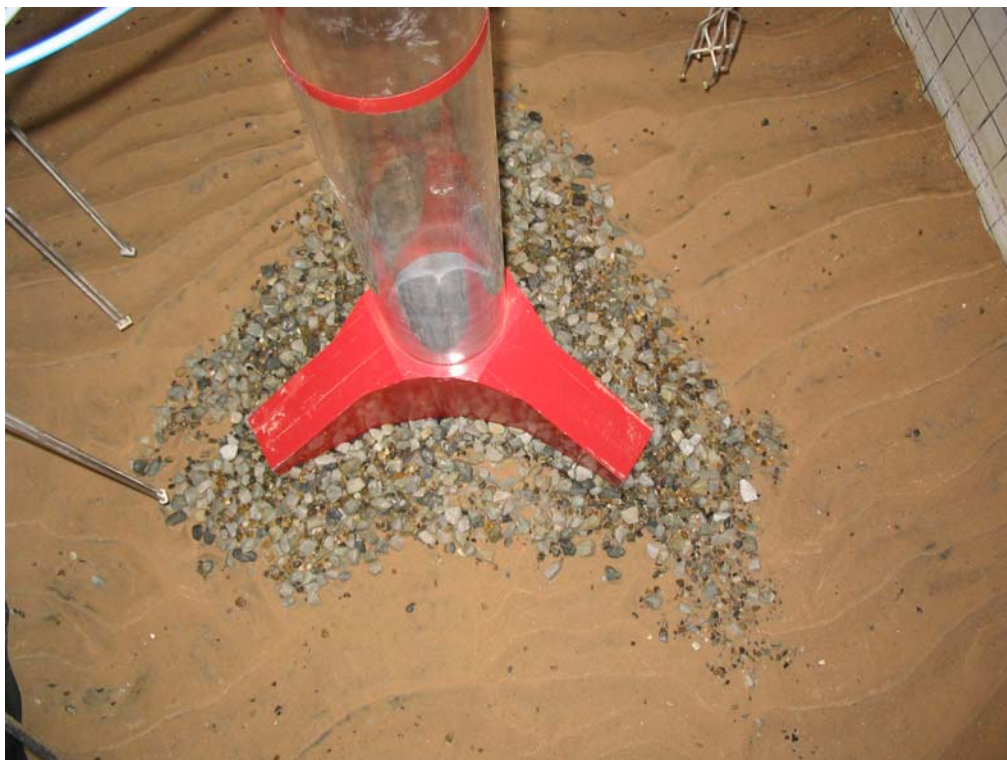
In this test protection type number four was used. It has a D_{50} of 365 mm.

Figure 1.21. Shape of scour protection at the end of 2.7.
No severe damage.

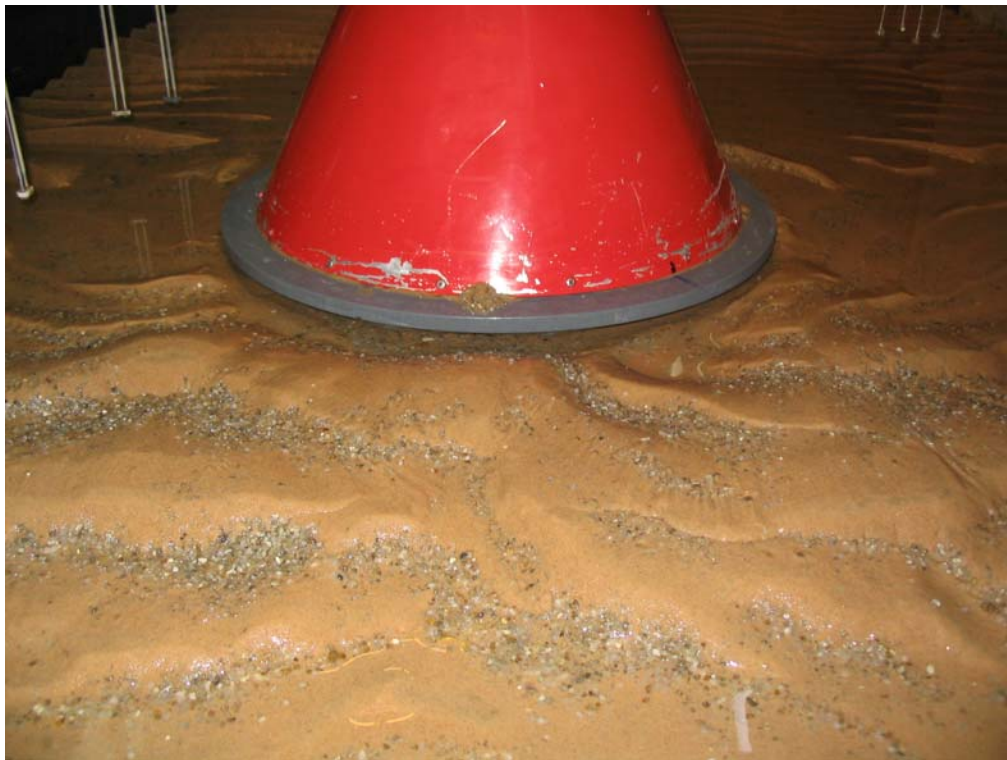
In this test protection type number one was used. It has a D_{50} of 93 mm.

Figure 1.23. Shape of scour protection at the end of 2.8.
Complete damage. 1.0 m scour depth.

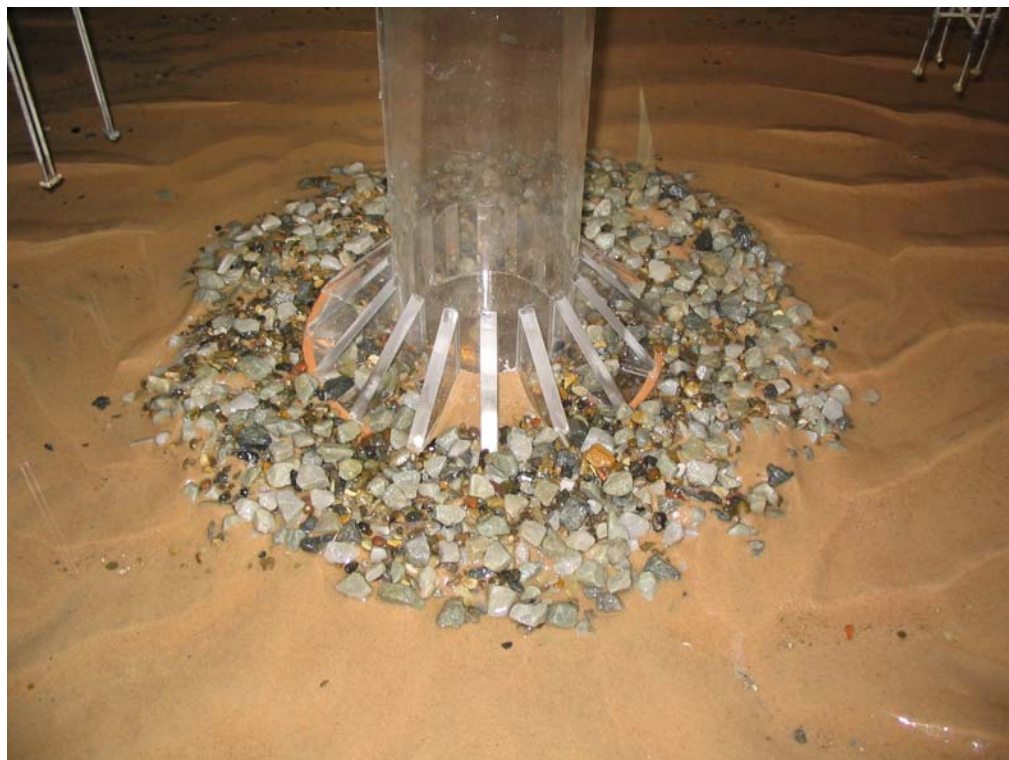
Figure 1.25. Shape of scour protection at the end of 2.9.
No severe damage.

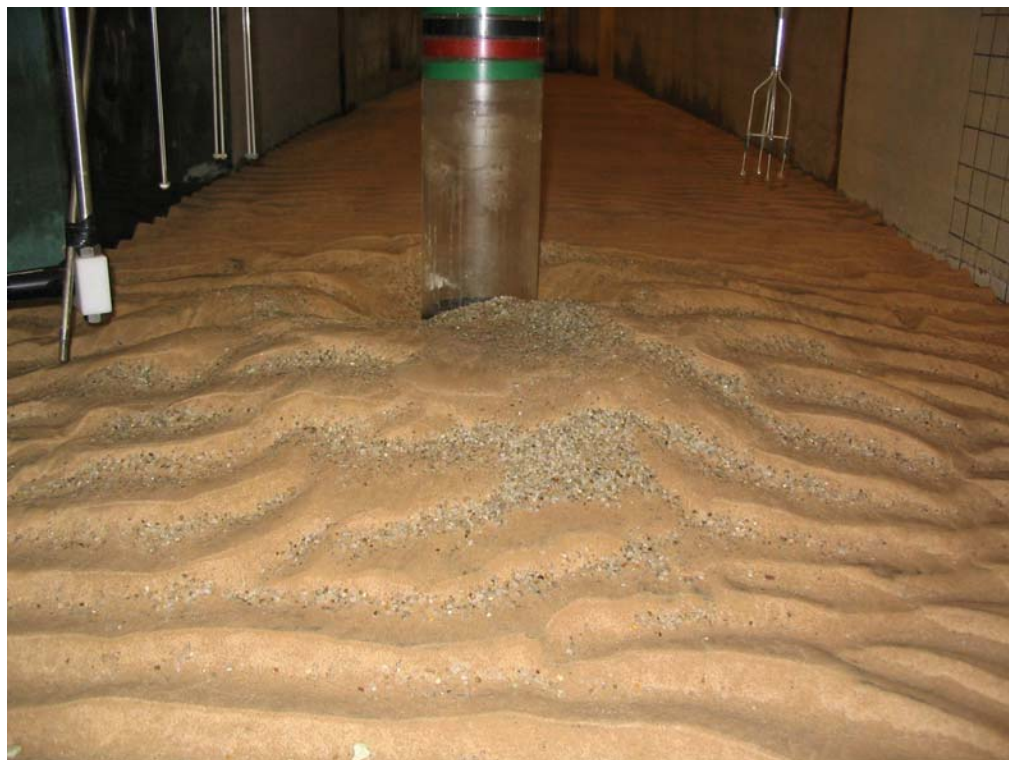
In this test protection type number one was used. It has a D_{50} of 93 mm.

Figure 1.27. Shape of scour protection at the end of 3.1.
Complete damage. 2.5 m scour depth.

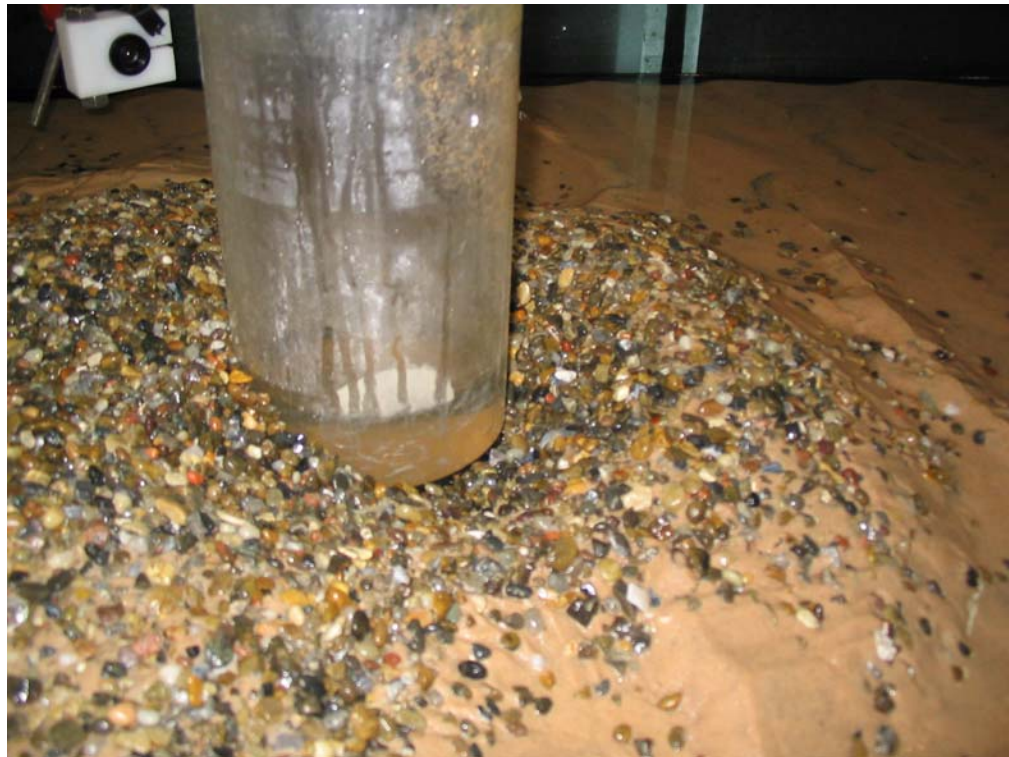
In this test protection type number two was used. It has a D_{50} of 258 mm.

Figure 1.29. Shape of scour protection at the end of 3.2.
Some damage. 1.5 m scour depth.

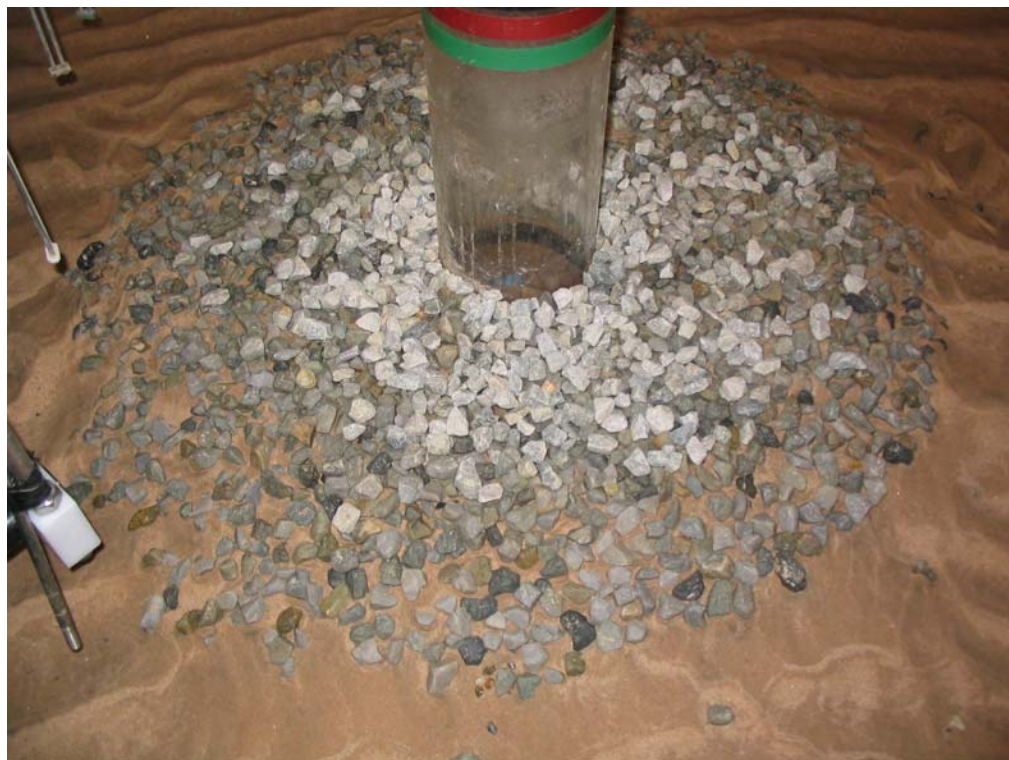
In this test protection type number three was used. It has a D_{50} of 585 mm.

Figure 1.31. Shape of scour protection at the end of 3.3.
No damage occurred.

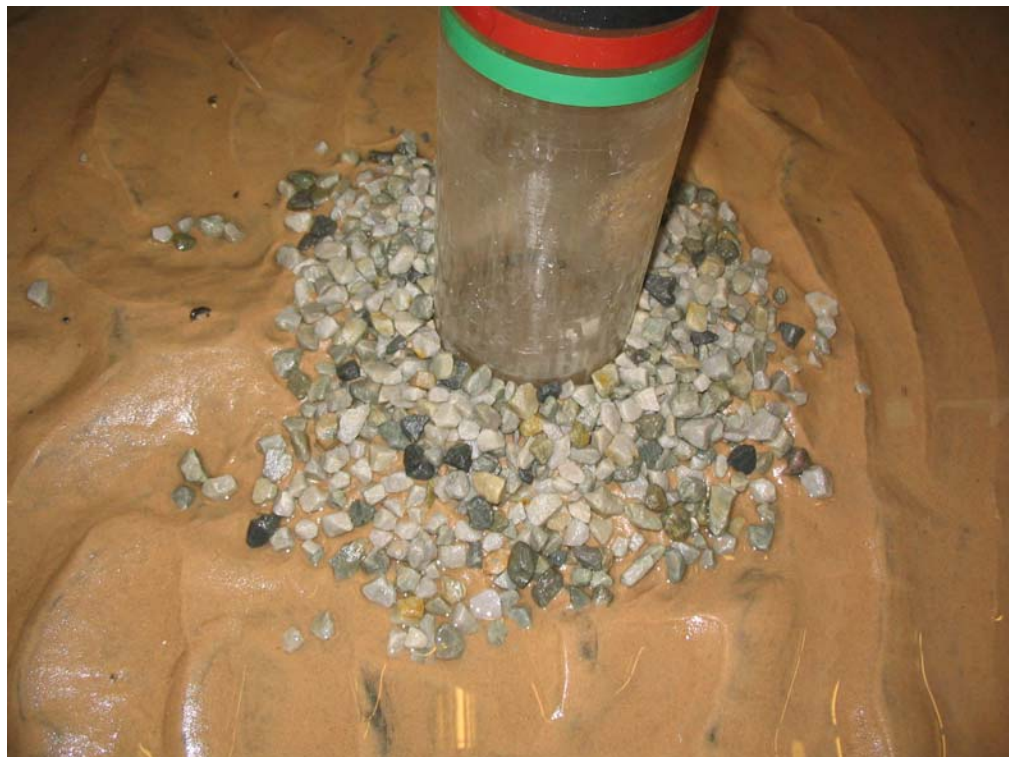
In this test protection type number three was used. It has a D_{50} of 585 mm.

Figure 1.33. Shape of scour protection at the end of 3.4.
No severe damage.

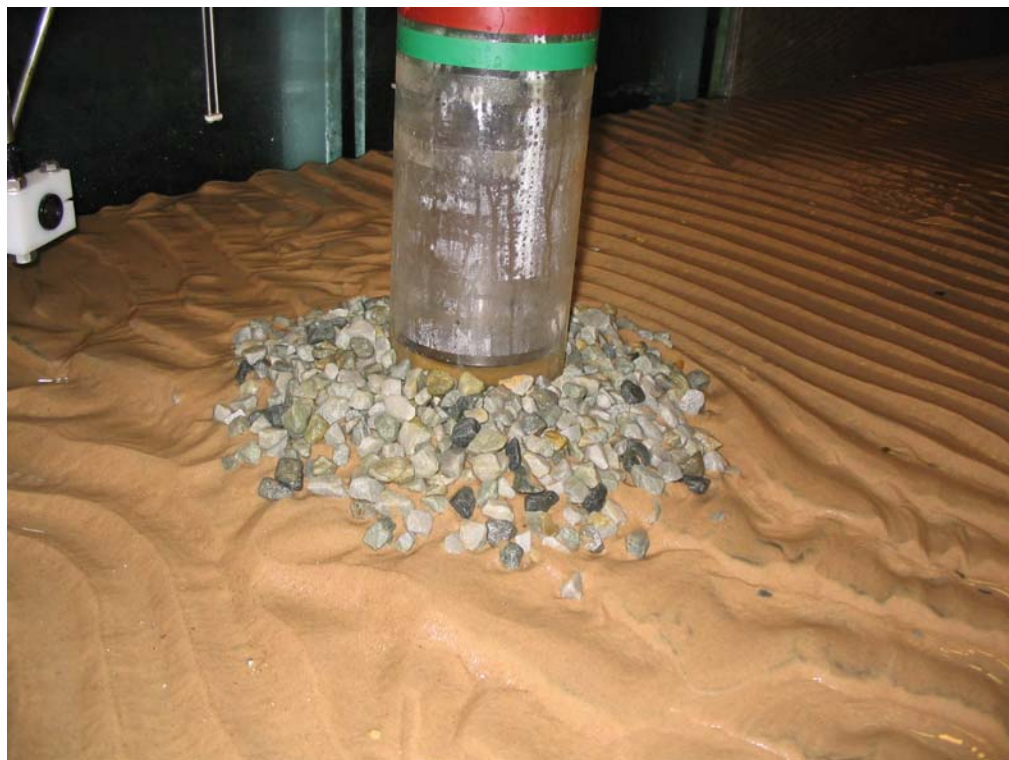
In this test protection type number three was used. It has a D_{50} of 585 mm.

Figure 1.35. Shape of scour protection at the end of 3.5.
No severe damage.

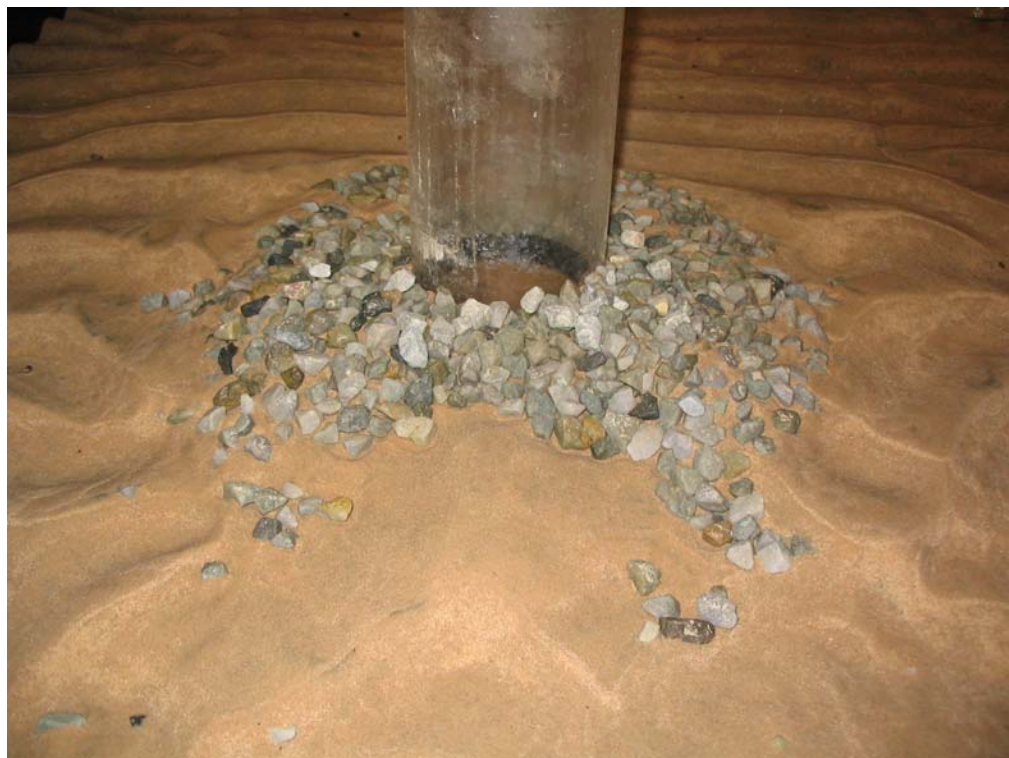
In this test protection type number three was used. It has a D_{50} of 585 mm.

Figure 1.37. Shape of scour protection at the end of 3.6.
No severe damage.

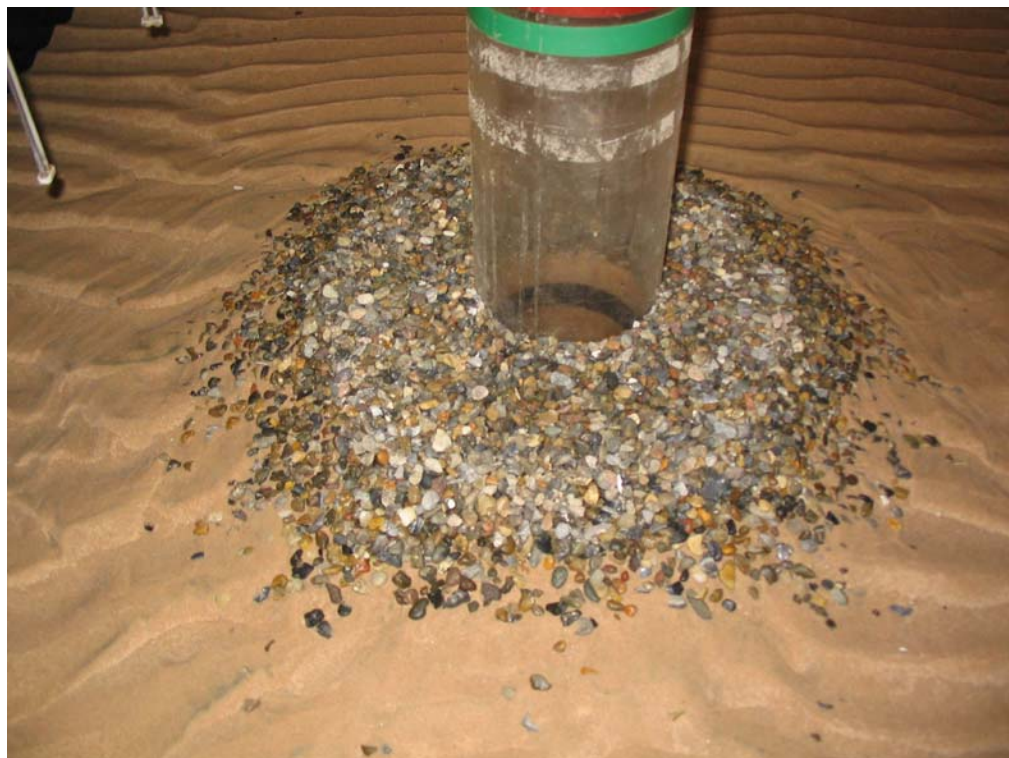
In this test protection type number two was used. It has a D_{50} of 258 mm.

Figure 1.43. Shape of scour protection at the end of 3.9.
No damage occurred.

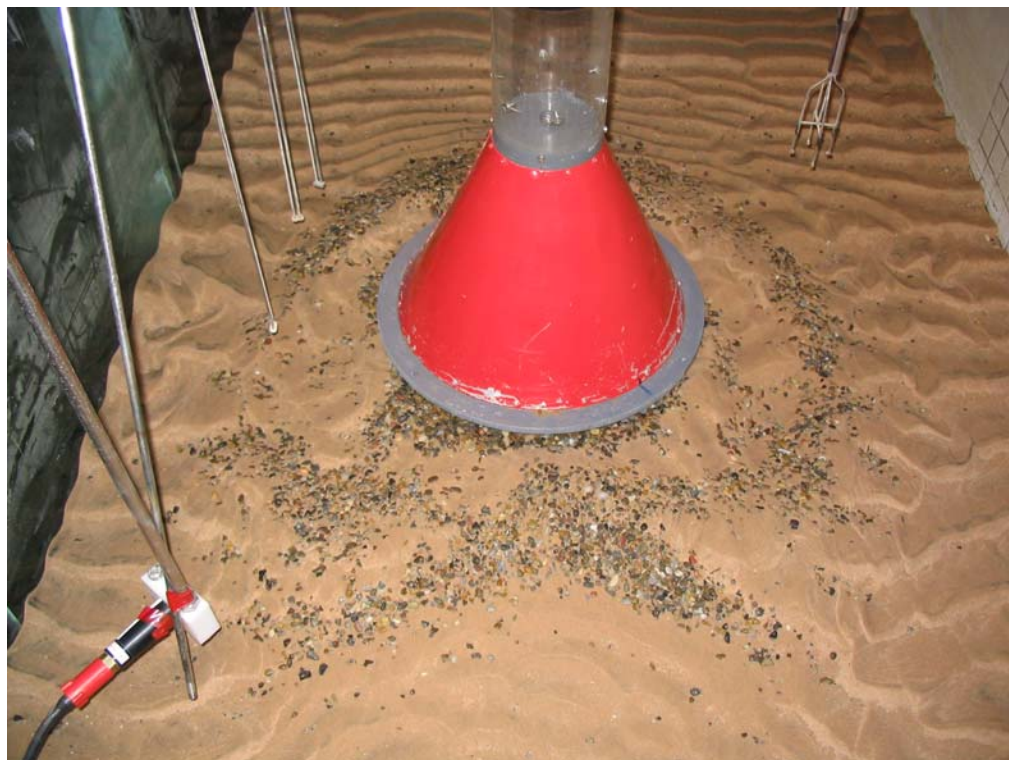
In this test protection type number two was used. It has a D_{50} of 258 mm.

Figure 1.47. Shape of scour protection at the end of 3.11.
Complete damage. 1.0 m scour depth.

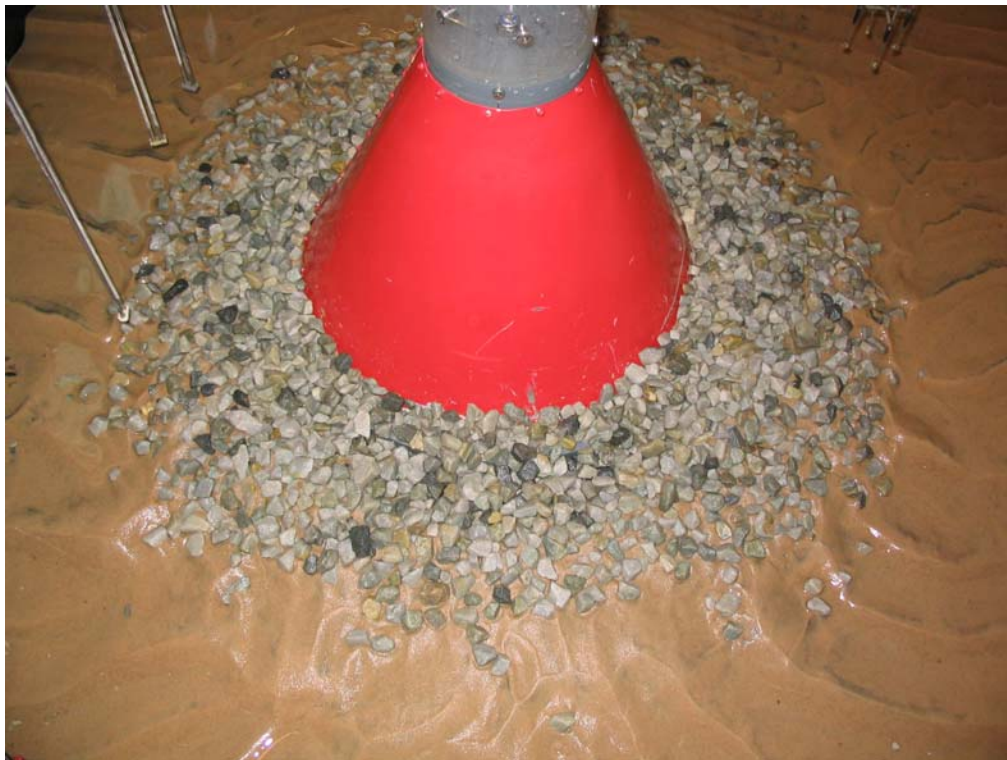
In this test protection type number three was used. It has a D_{50} of 585 mm.

Figure 1.49. Shape of scour protection at the end of 3.12.
No damage occurred.

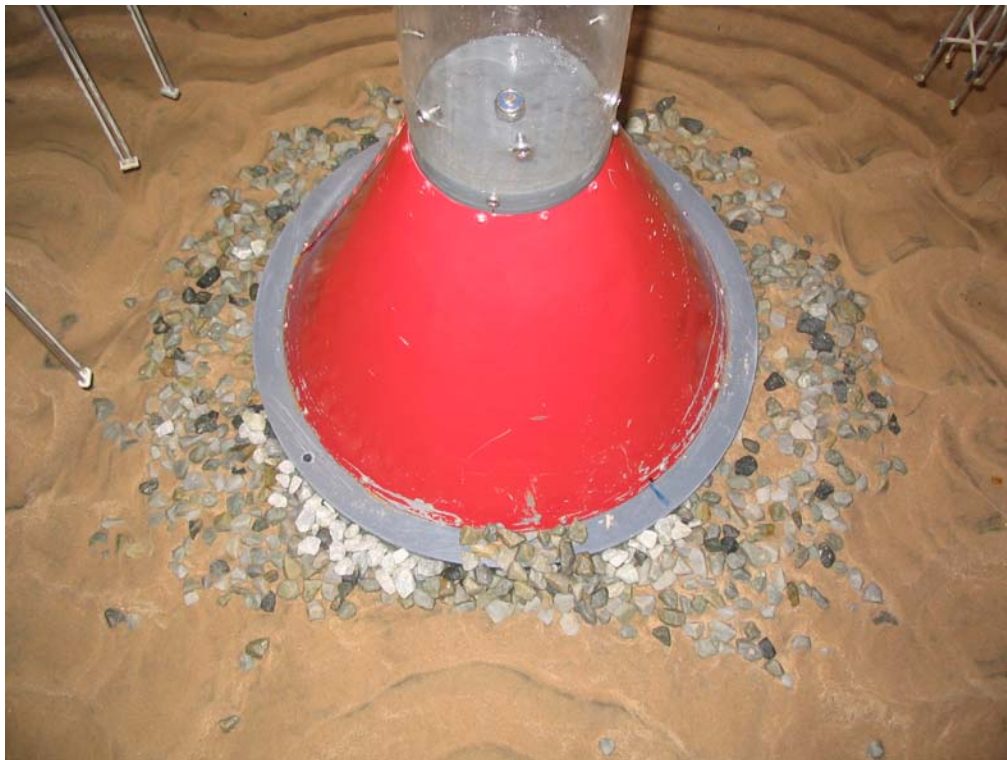
In this test protection type number three was used. It has a D_{50} of 585 mm.

Figure 1.51. Shape of scour protection at the end of 3.13.
Some damage. 1.0 m scour depth.

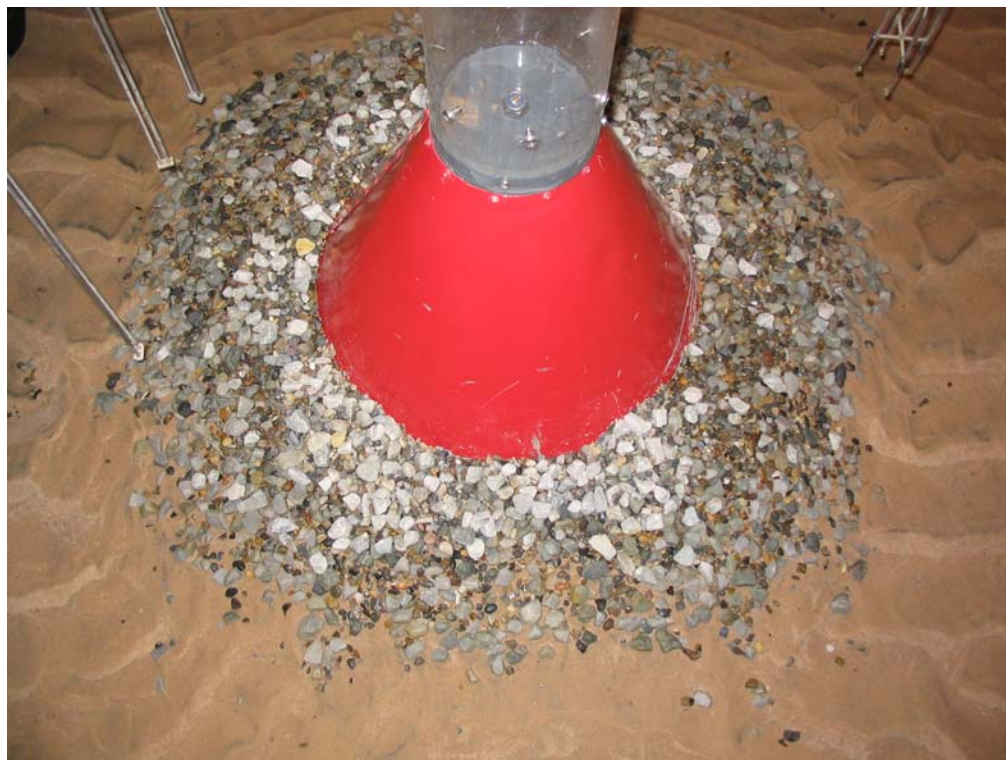
In this test protection type number four was used. It has a D_{50} of 365 mm.

Figure 1.53. Shape of scour protection at the end of 3.14.
No damage occurred.

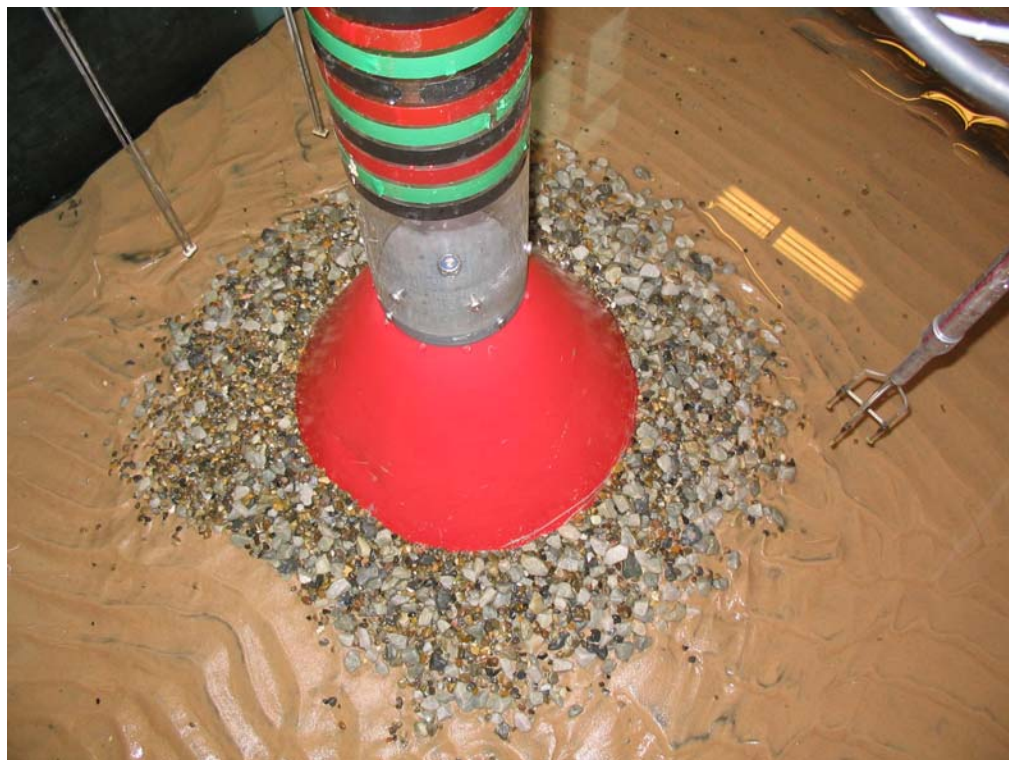
In this test protection type number four was used. It has a D_{50} of 365 mm.

Figure 1.55. Shape of scour protection at the end of 3.15.
No damage occurred.

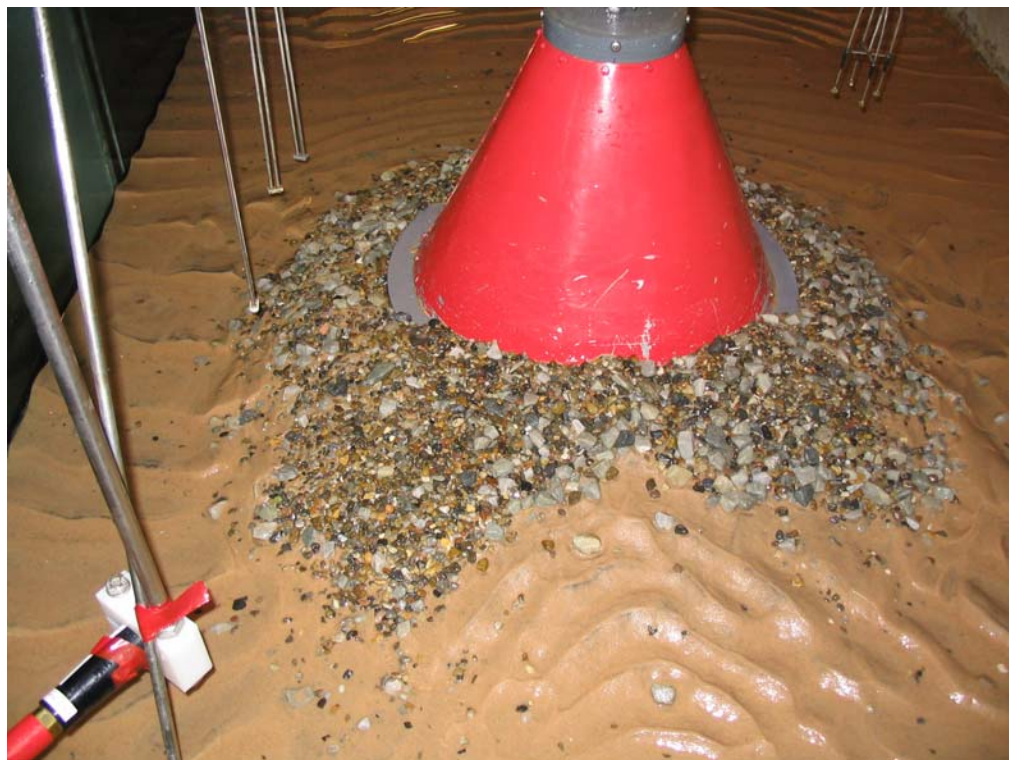
In this test protection type number four was used. It has a D_{50} of 365 mm.

Figure 1.57. Shape of scour protection at the end of 3.16.
No damage occurred.

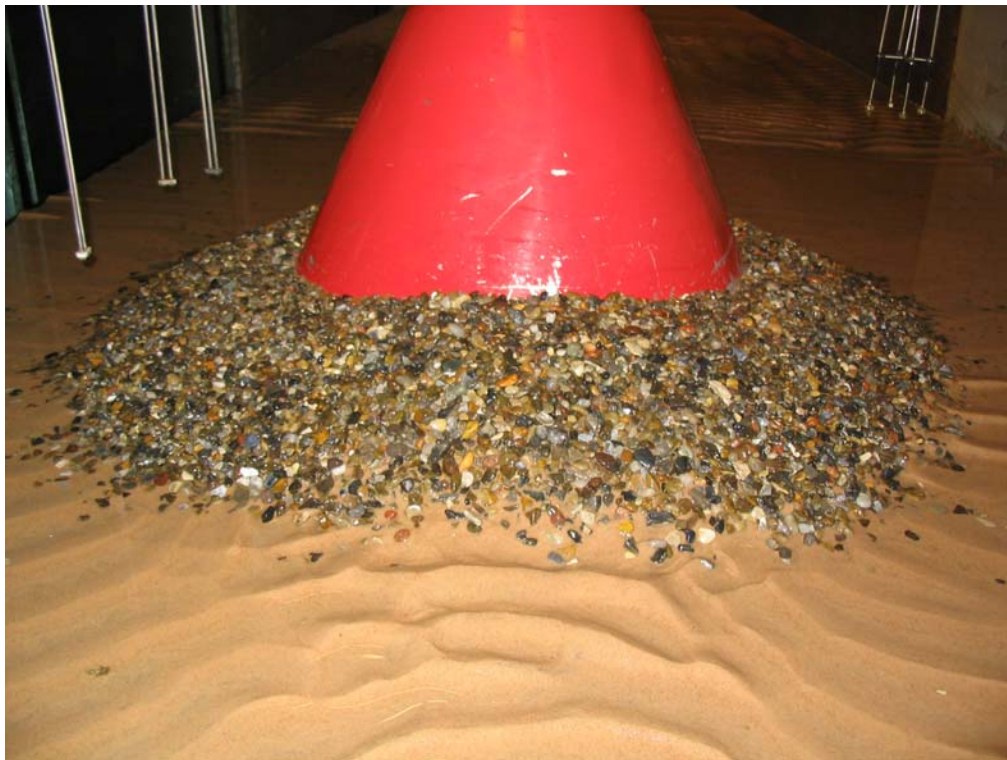
In this test protection type number two was used. It has a D_{50} of 258 mm.

Figure 1.59. Shape of scour protection at the end of 3.17.
No damage occurred.

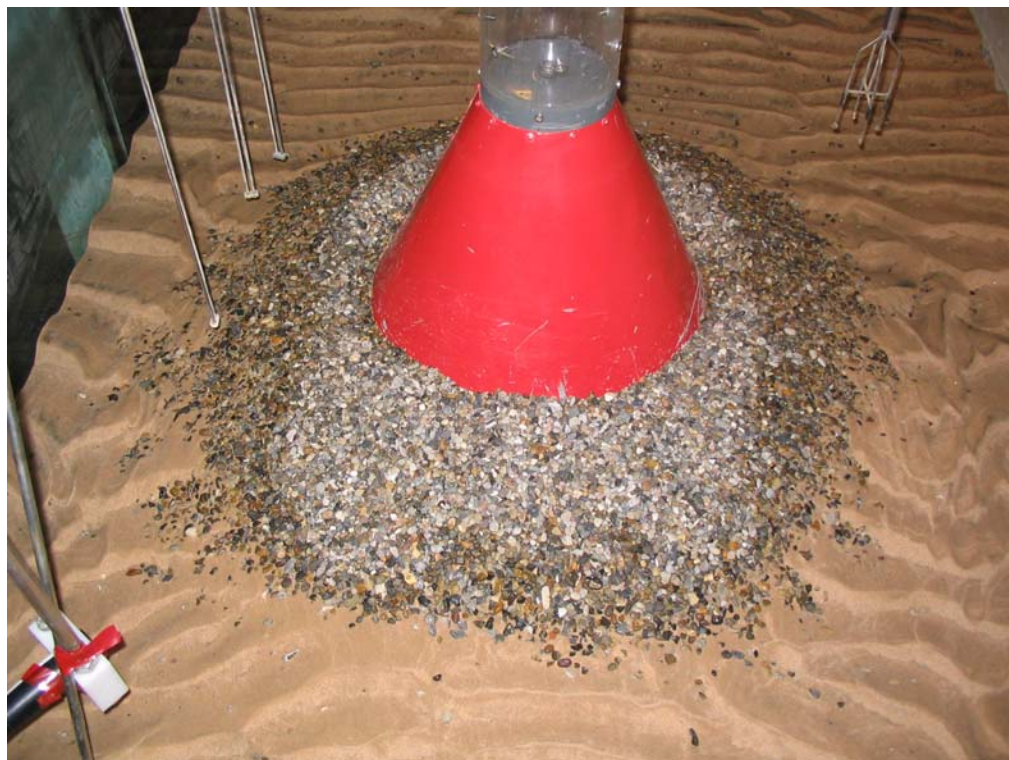
In this test protection type number two was used. It has a D_{50} of 258 mm.

Figure 1.61. Shape of scour protection at the end of 3.18.
No damage occurred.

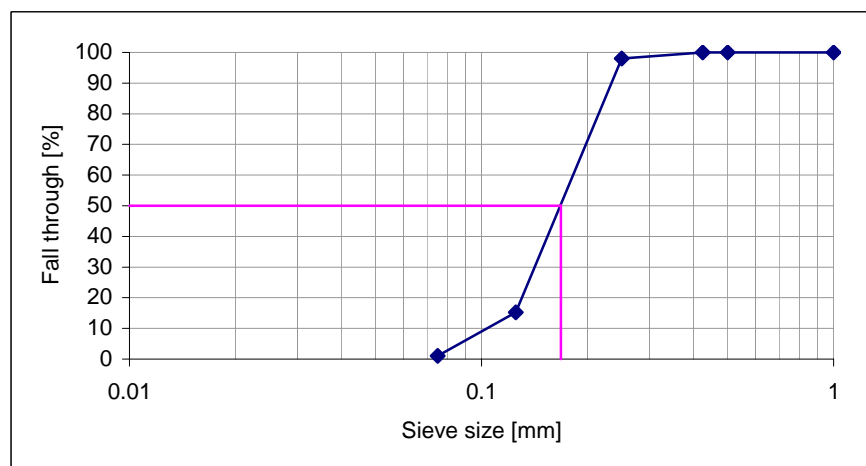
Table 3.1. Grain size distribution. D_{50} is 0.17 mm.
In prototype scale D_{50} is 8.4 mm.

Figure 3.1. Grain size distribution curve.

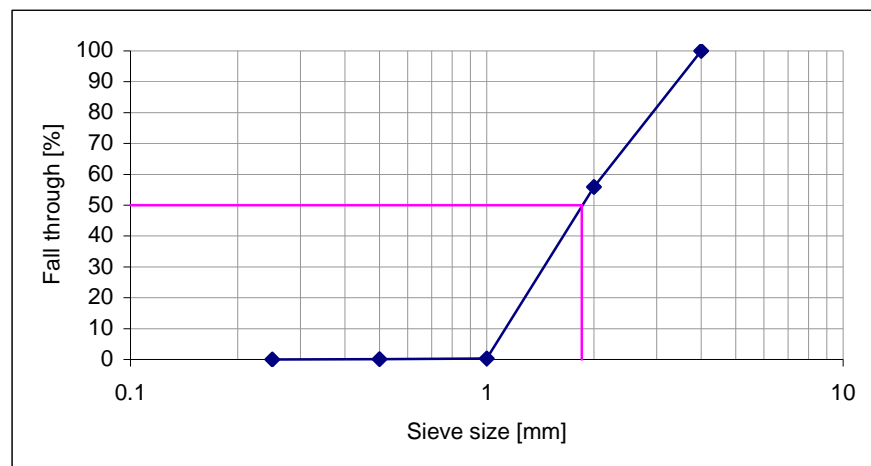
Table 3.2. Grain size distribution. D_{50} is 1.85 mm.
In prototype scale D_{50} is 93 mm and W_{50} is 1.21 kg.

Figure 3.2. Grain size distribution curve.

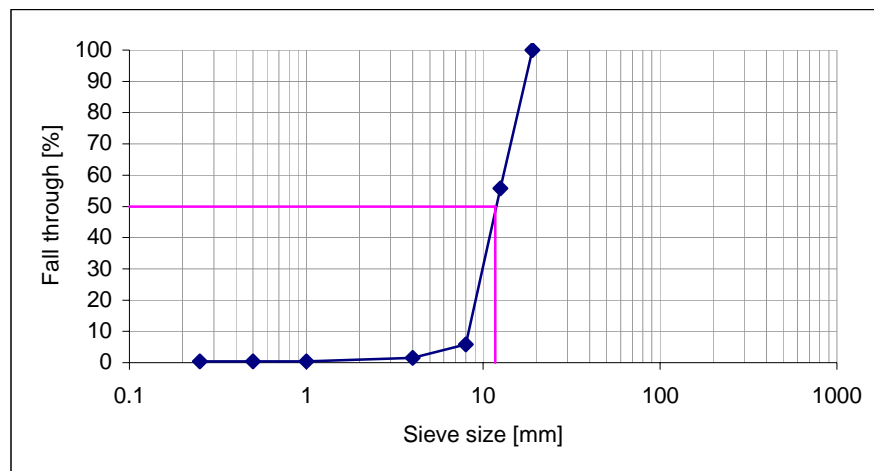
Table 3.4. Grain size distribution. D_{50} is 11.7 mm.
In prototype scale D_{50} is 585 mm and W_{50} is 307 kg.

Figure 3.4. Grain size distribution curve.

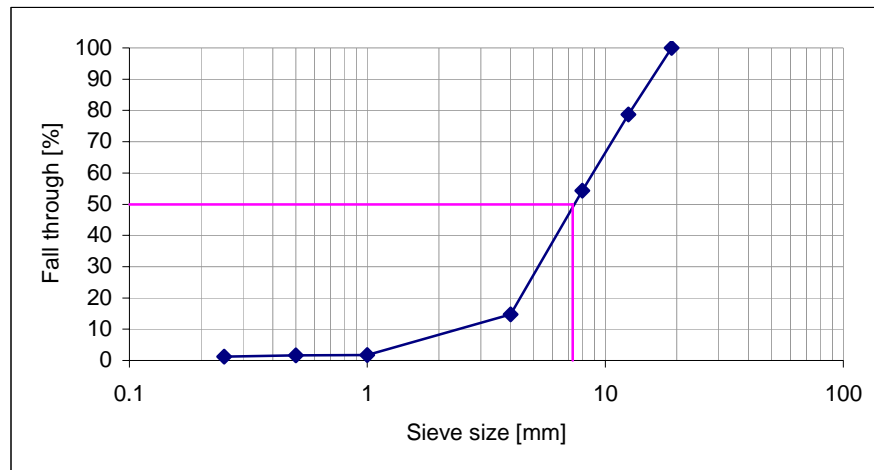
Table 3.5. Grain size distribution. D_{50} is 7.3 mm.
In prototype scale D_{50} is 365 mm and W_{50} is 74.6 kg.

Figure 3.5. Grain size distribution curve.
